## P2-406-i24 Phase I

### Landfill 120, Silkstone

Active Layer: Landfill 120

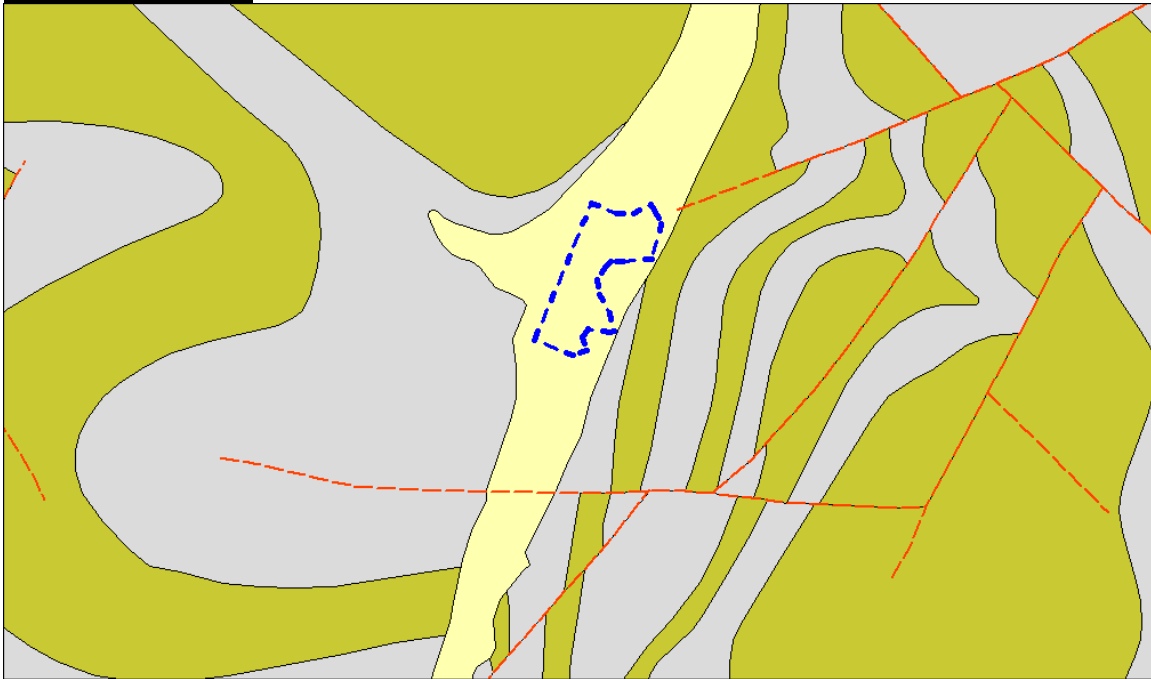
## **2.0 Site Geology**

This area lies upon the Lower Coal Measures formation (LCM) which dominates much of the underlying geology in this part of the Borough. The site lies mainly upon a band of undivided Cyclic Sedimentary Rock, i.e. mudstone and shale (indicated in grey). To the north and east of the site are bands of LCM-Sandstone (indicated in green) and the whole site is overlain by alluvial deposits associated with Silkstone Dike.

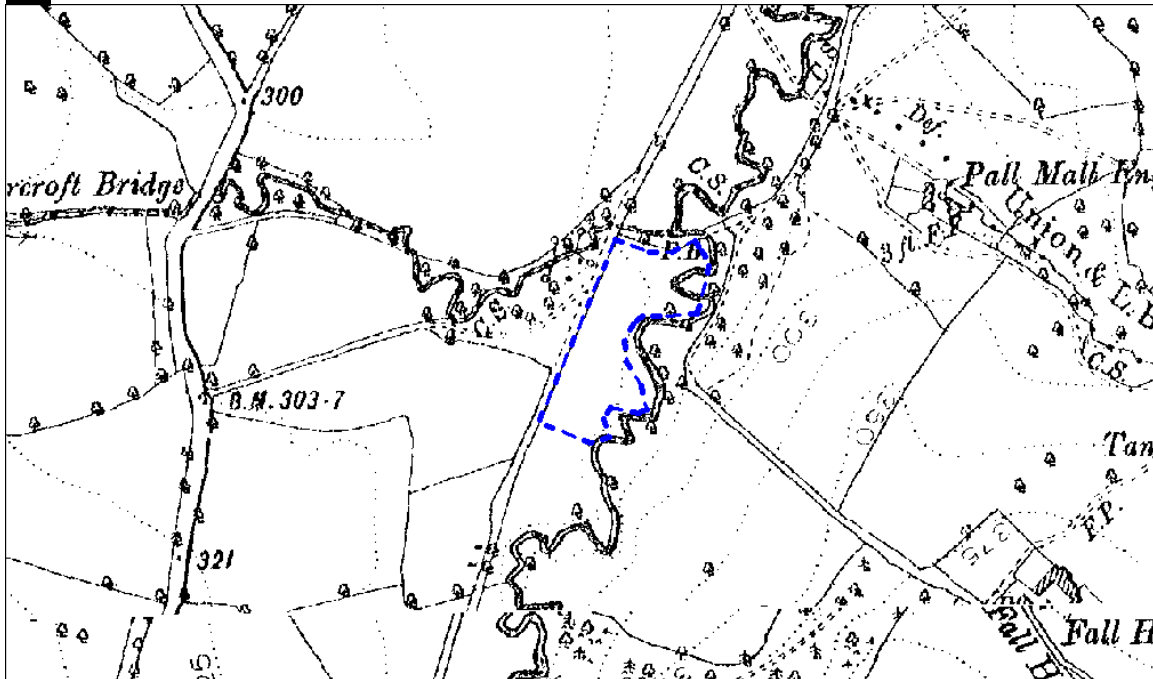
##### 5.1 1895

The site sits in an area of agricultural land at the confluence of 2 streams. There are small areas of woodland to the east and west

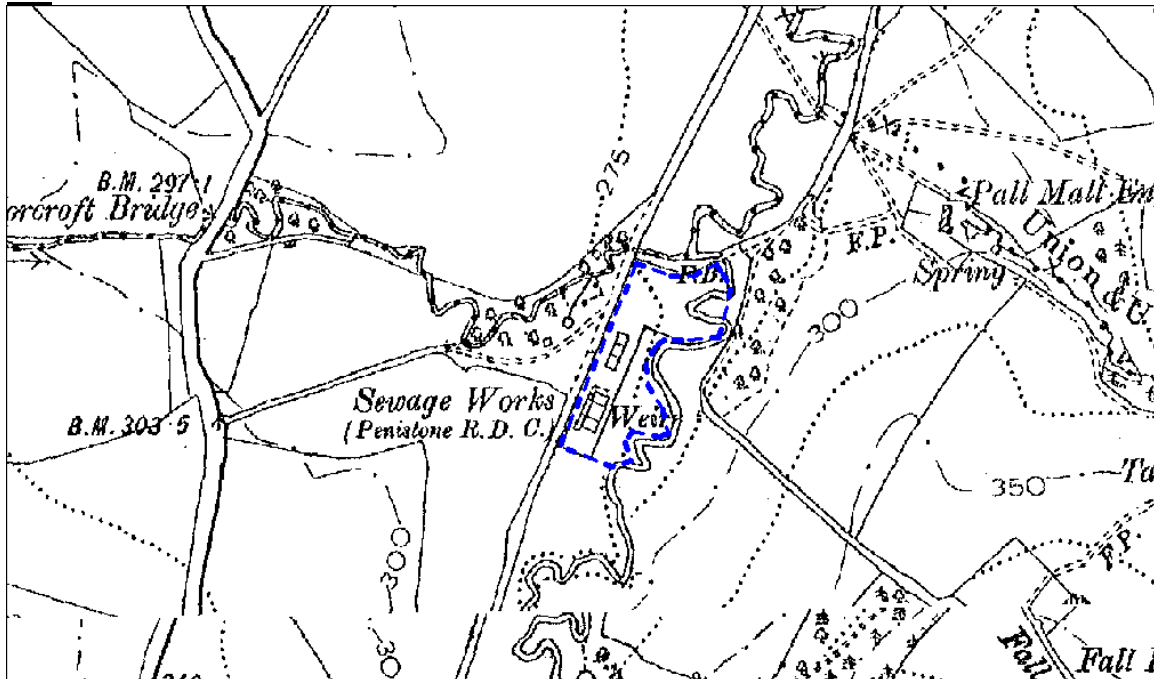
## 5.2 1910

There is now a sewage works occupying the site. The surrounding area looks much the same

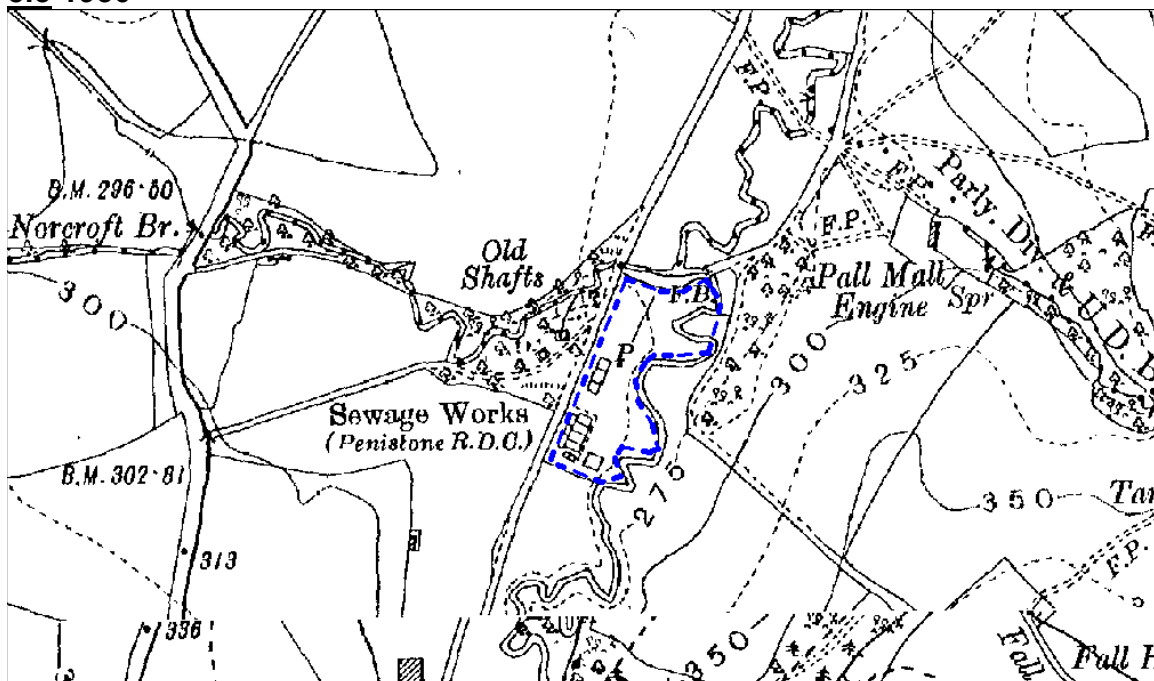
## 5.3 1930

There are now some old shafts marked just to the west of the site, indicating that there has been mining activity in this area

There is deposition of material around the old shafts to the west. Further to the west there are a group of Works buildings of unknown purpose

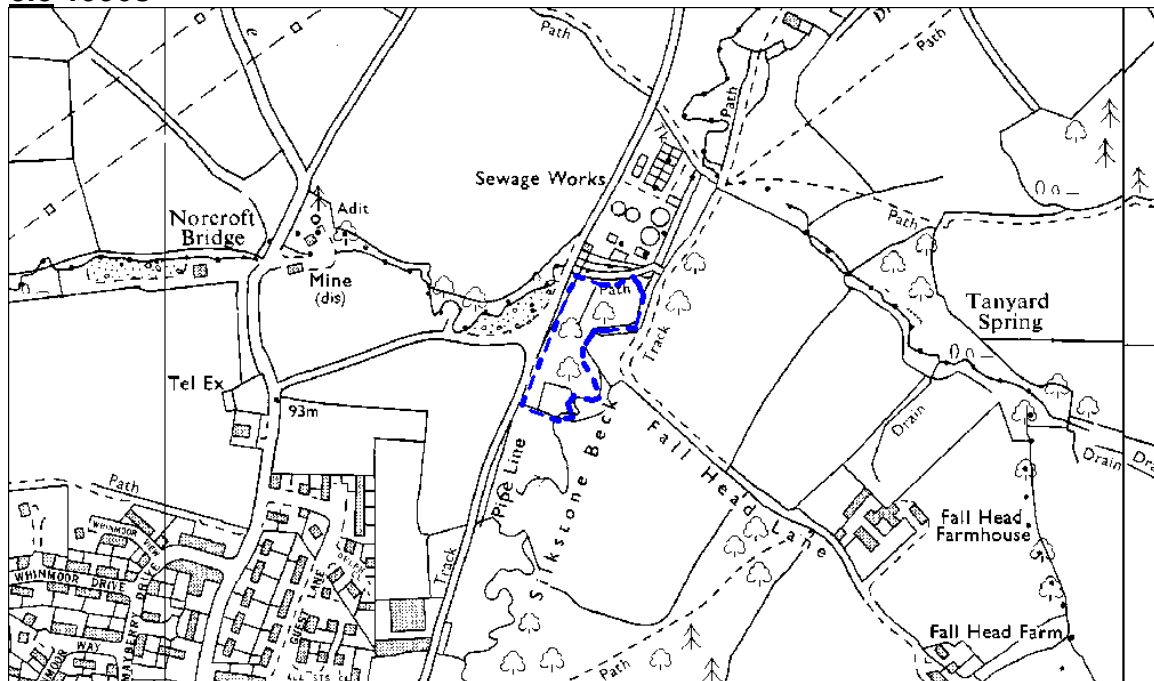
## 5.5 1990s

The site is now covered in woodland and the works buildings to the west are indicated as a disused mine. The landfill activity is known to have occurred in the time between the previous historical map and this one
