Supplementary Planning Document

**Elsecar Conservation Area Design
and Maintenance Guide**

Adopted November 2019

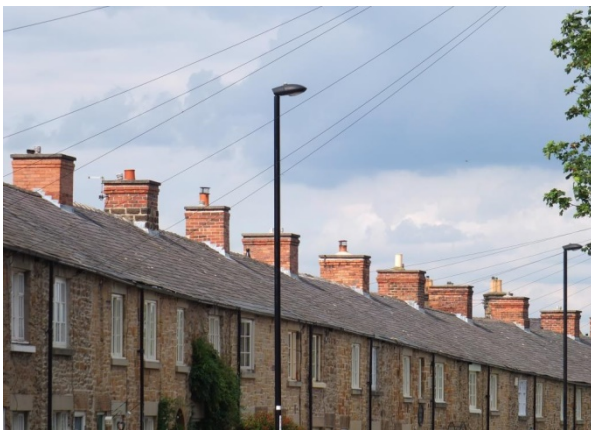
Photo 1 – replaced brick flues on Reform Row with simple high level string course

10.1.4 Care should be taken to replicate any historic design features and architectural detailing to chimneys should always be retained. In Elsecar the chimneys on domestic buildings tend to be relatively plain, but some have corbel bands, string courses, stone caps or oversailing courses where the stack increases in circumference at higher level. These details are important features and form part of a property's historic character. The removal of such architectural detailing by rebuilding a stack in straight or unadorned courses, or removing higher level masonry to reduce the height of a stack, has a negative impact on the overall character of the building and should be avoided.

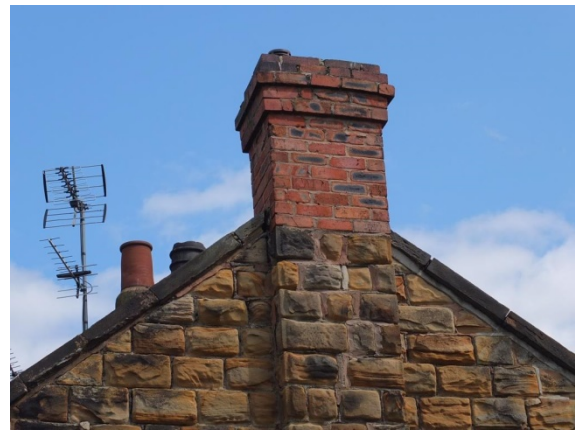
Photo 2 – replaced brick flue with over-sailing courses

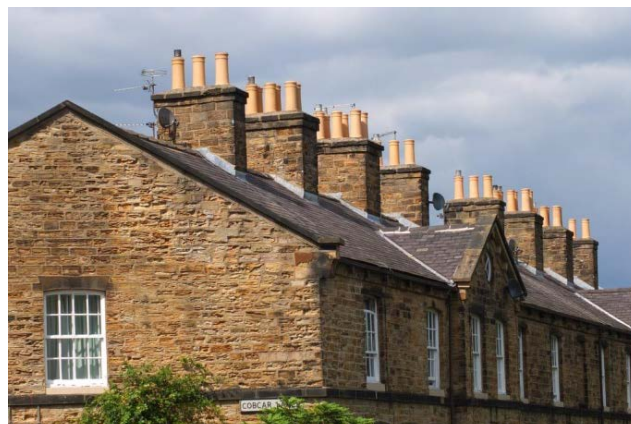
Photo 3 – restored chimney pots, Cobcar Terrace

10.1.3 Chimney pots are a key part of the character of a chimney and should also be retained or repaired/replaced wherever possible. Repaired/replaced chimney pots can make a significant positive contribution both to a historic property and to the wider heritage value of the Conservation Area (see photo 3). If a pot needs to be replaced then the replacement should match the remaining pots in terms of its material (terracotta / glazed) size, shape and colour.

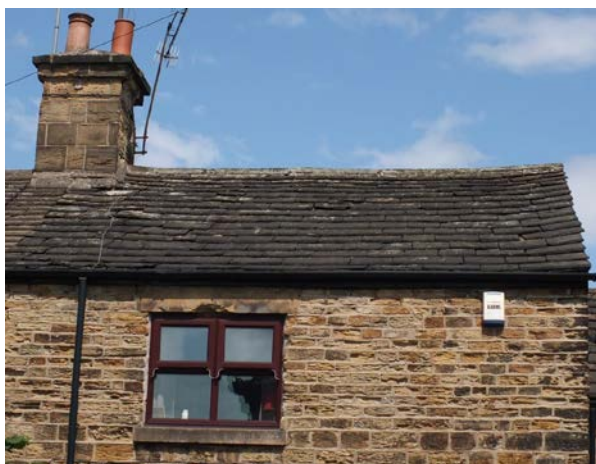
Photo 4 – stone flag gable roof (Fitzwilliam Street)

10.2.1 In Elsecar most historic buildings have roofs covered with blue Welsh slate although there are a number of stone slate roofs, generally associated with the earliest, pre-1790s buildings (photo 4). It is likely that the early workers housing also had stone roofs, but these have been replaced with Welsh Slate (with the exception of some of the cottages on Distillery Side). Welsh Slate became more readily available after the construction of the canal network, and its popularity grew after the railway networks were established in the mid-19th century.

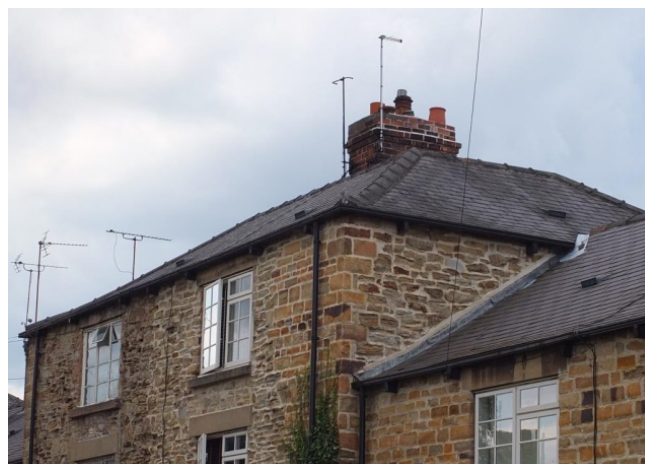
Photo 5 – hipped Welsh slate roof (Station Row)

10.2.3 There are examples of both gable roofs and hipped roofs on historic properties within the conservation area (photos 5 and 6). For gable roofs, the edge of the roof, where it meets the gable wall, is known as the verge. In Elsecar, verges are normally either finished with a straight mortar fillet (photo 7) or have verge coping - i.e. coping stones that run along the top of the gable forming the edge of the roof (photo 6). Again, these are important architectural features and should be retained. Verge coping should always be in natural sandstone. Projecting gable bargeboards (decorative timber panels) are not historically typical or widespread in Elsecar.

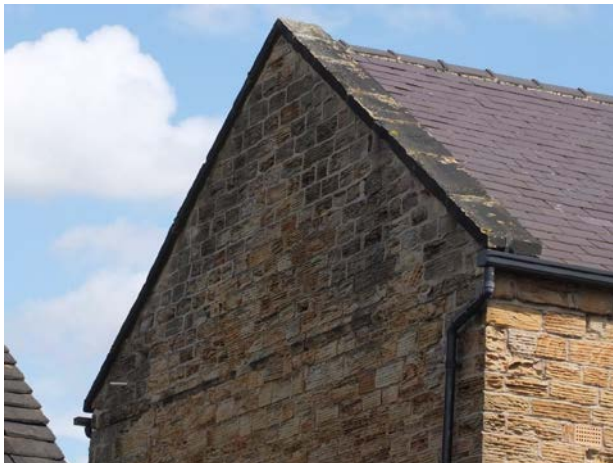
Photo 6 – Welsh slate gable roof with verge coping

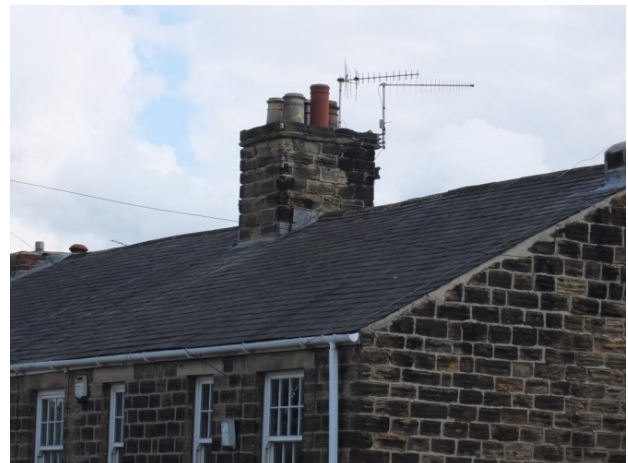
Photo 7 – Welsh slate gable roof with mortar fillet finish

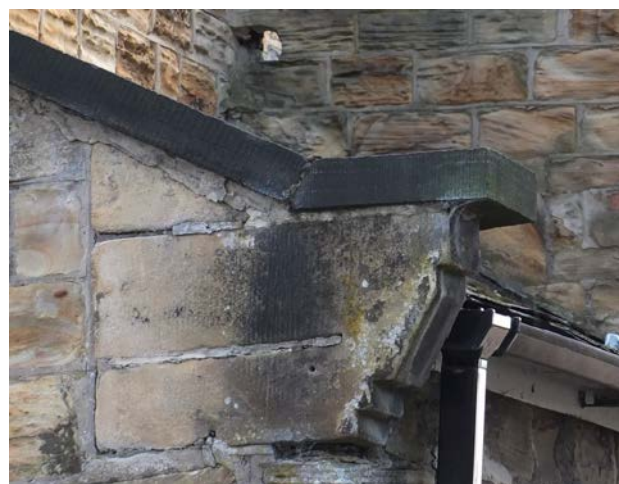
Photo 8 – Kneeling stone at the edge of the gable, supporting the verge coping

10.2.4 A number of the historic properties in Elsecar also have kneelers or skew corbels. These are decorative stonework pieces that support the gable/verge coping and terminate in a small overhang above the gutter (see photo 8). In Elsecar these are typically seen in properties dating from the mid-late 19th century. Frequently used as a stop for eaves gutters kneelers or skew corbels are an important architectural detail and should be retained and repaired if needed.

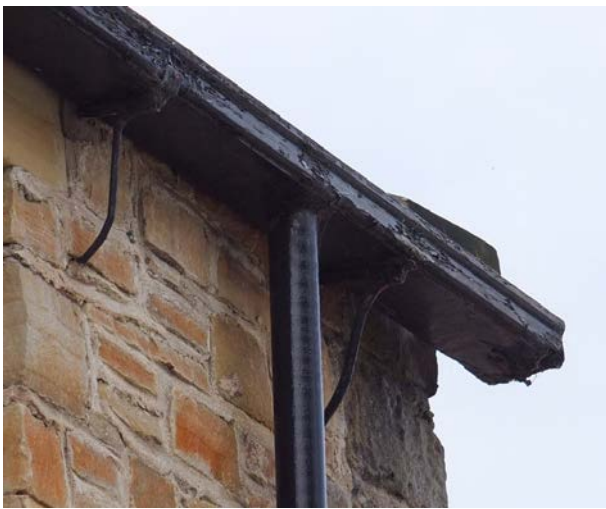
Photo 9 – Wooden box section gutter supported by rise and fall metal spikes

boards, but instead use metal spiked rise and fall brackets (photo 9), cast iron round brackets (photo 11) or stone or wooden corbels beneath the gutter (photo 10). Fascia boards are not typical in Elsecar and therefore should not be introduced unless they are pre-existing and clearly historic.

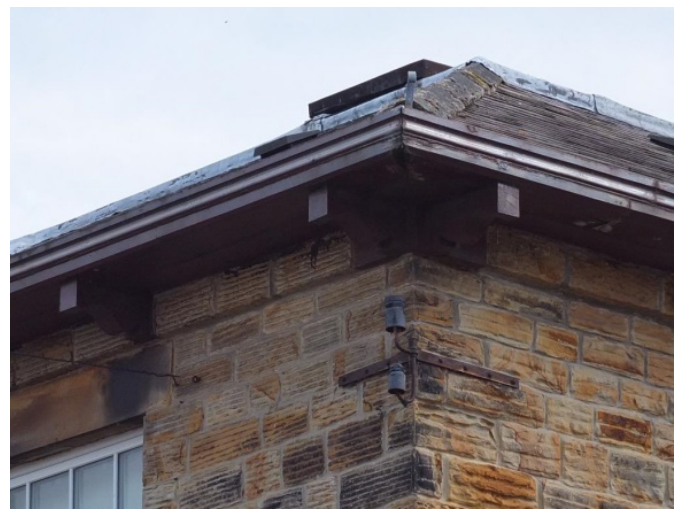
Photo 10 – Wooden box section gutter supported by wooden corbels

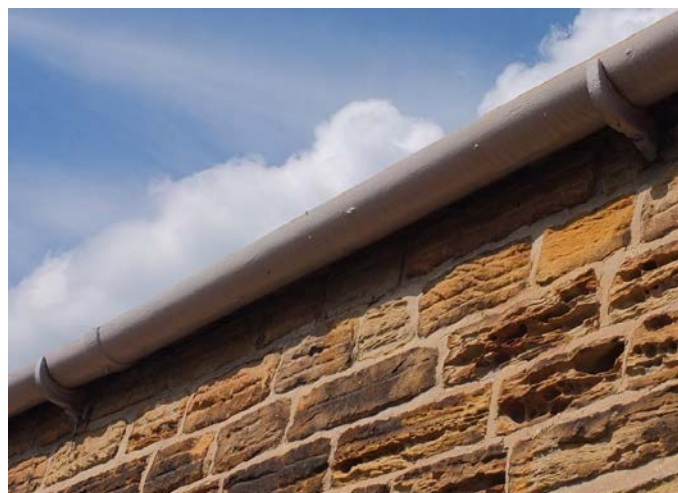
Photo 11 – Round, cast-iron gutter, supported on cast iron brackets

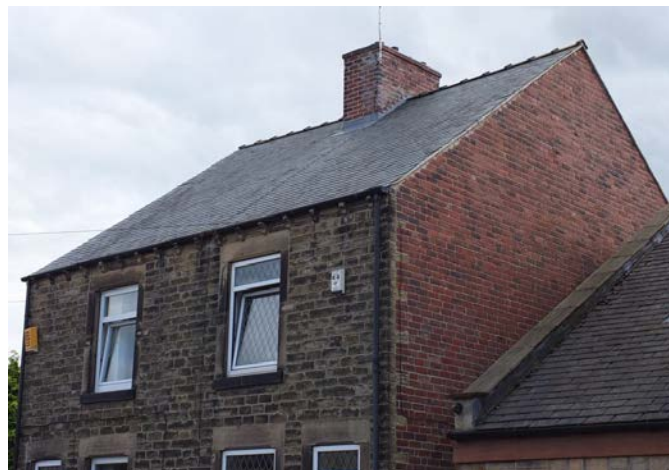
Photo 12 – Historic property with stone front elevation and brick elevations to side

10.4.1 In Elsecar, principal elevations of historic properties tend to be of sandstone, although some properties have front elevations of stone and side and rear elevations of brick (see photo 12). This tends to be seen in properties dating from the mid-late 19th century although there are some earlier examples. Any repairs to the external elevations of historic properties should use materials to match the existing.

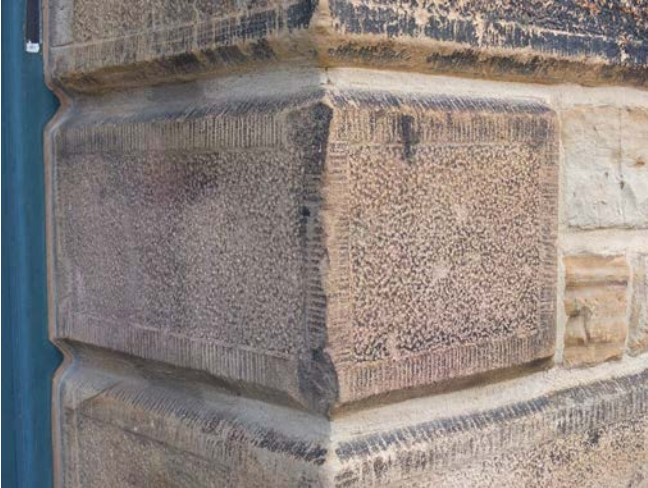
Photo 13 – Pitch faced stonework, in Elsecar this finish tends to be used for quoins (large rectangular stones at the corners of walls)

10.4.3 Older properties may require stone replacement of the outer skin where weathering has progressed to such an extent, replacement of wall stone is the only option. In such circumstances, a natural sandstone, with a similar colour, grain size and face finish should be used. A number of different sorts of stone dressing can be seen in Elsecar, including parallel punch finishing and pitch faced (see photos 13 and 14).

10.4.4 On the whole, pitch faced is used for quoins (large stones on the corner of walls, usually on the building corner or around windows and doors) and parallel punch is used for main elevations. Both are decorative and an important design feature. A simpler, split faced finish is also found on some

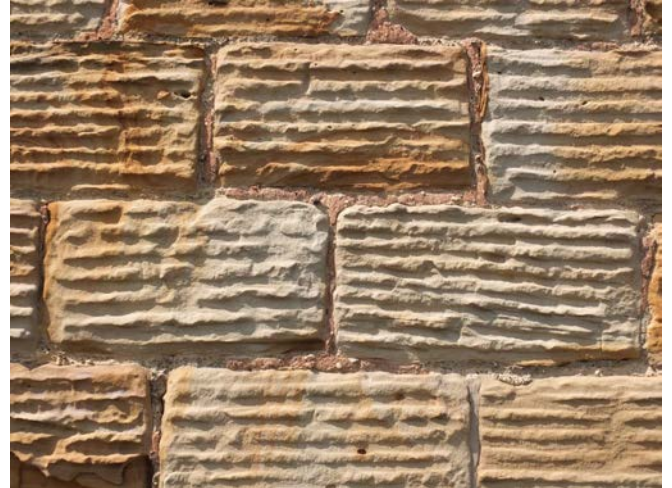
Photo 14 – Parallel punch stonework, a common design feature seen in Elsecar on the exterior of historic buildings

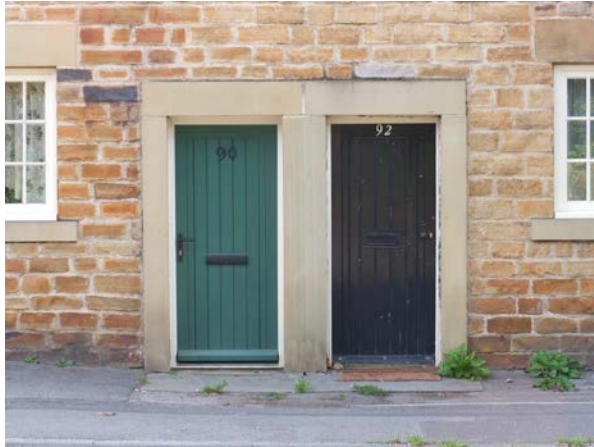
Photo 15 – simple monolithic jambs and heads to doorways (Meadow Row)

10.4.7 Stone detailing of openings is common and windows and doorways may include stone canopies, carved heads, cills and jambs to reinforce (visually and literally) these features. At higher levels, architectural details and features such as string courses, gutter corbelling, kneelers / skew corbels, gutter architraves and round windows (oculi) are also common (see photos 18 - 21). These sorts of architectural features are an important part of the historic design of a property, as well as adding to its general appeal, and should always be retained or repaired in situ.

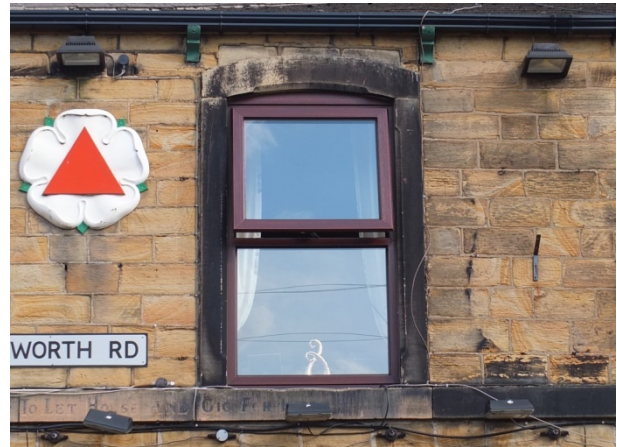
Photo 16 – carved stone head, jambs and sill band to window opening (Market pub)

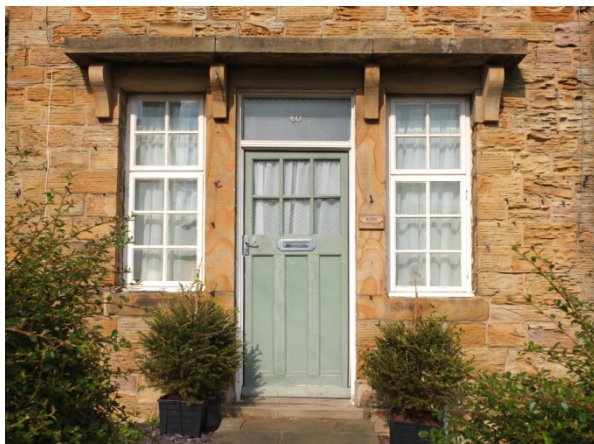
Photo 17 – simple stone canopy with stone corbels (Fitzwilliam Street)

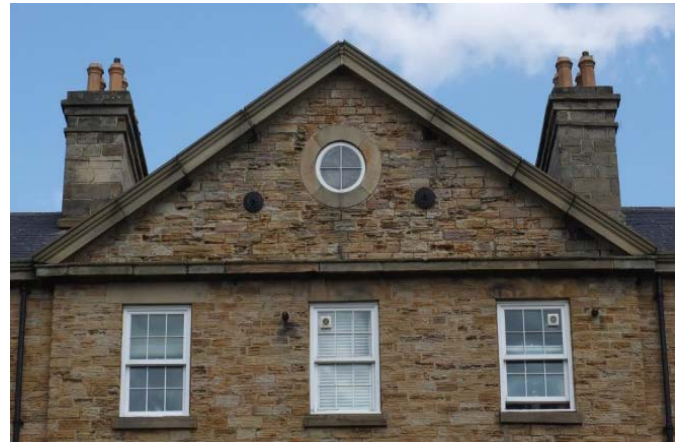
Photo 18 – oculus window with decorative gable string course (Miners' Lodging House)

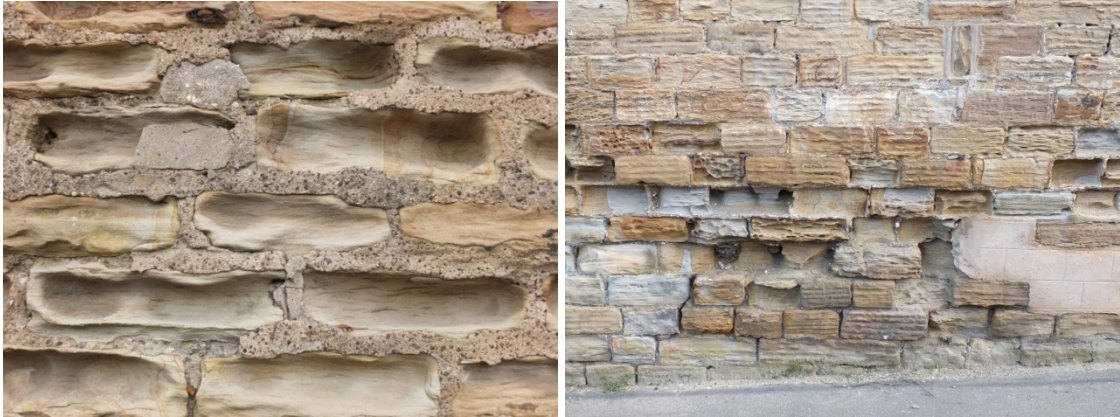
Photos 19 and 20 – damage to stonework caused by use of cement mortar and weathering

10.5.2 As a consequence of cement pointing, moisture cannot escape between the joints (as it should) and penetrates deeper into the stone, which results in accelerated weathering (photos 19 and 20). As such, breathable pointing that utilises naturally hydrated lime (NHL) should always be used when dealing with historic building.

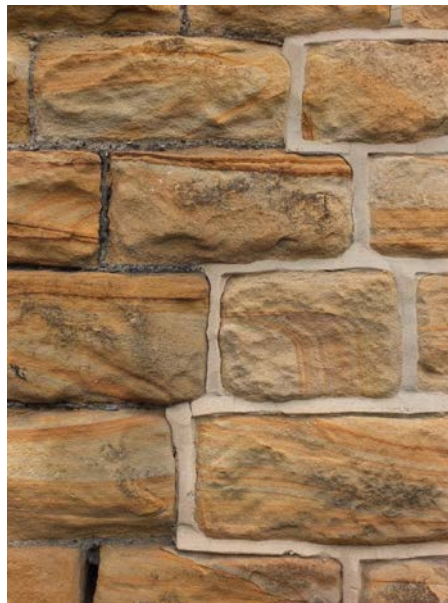
Photo 21 – inappropriate strap pointing repair

10.5.1 Although fairly common in Elsecar, Ordinary Portland Cement (OPC) based pointing and render is not appropriate on main, side or rear elevations. Due to the relative difference in hardness between cement pointing and sandstone (particularly in solid wall structures) combined with a general lack of breathability, this sort of pointing can cause damage to stone by forcing water through the stonework (rather than it escaping through the mortar). This is particularly true when cement pointing is applied and finished in a strap or ribbon fashion where the pointing stands proud of the joint and has exposed horizontal ledges where water can collect (photo 21).

Strap / Ribbon pointing – a style of pointing whereby the mortar is finished into a wide projecting band / strap / ribbon that overlap the face of the brick or stone behind. This style of pointing is not appropriate for historic buildings in Elsecar as it can cause irreversible damage to the soft stone by trapping moisture behind it

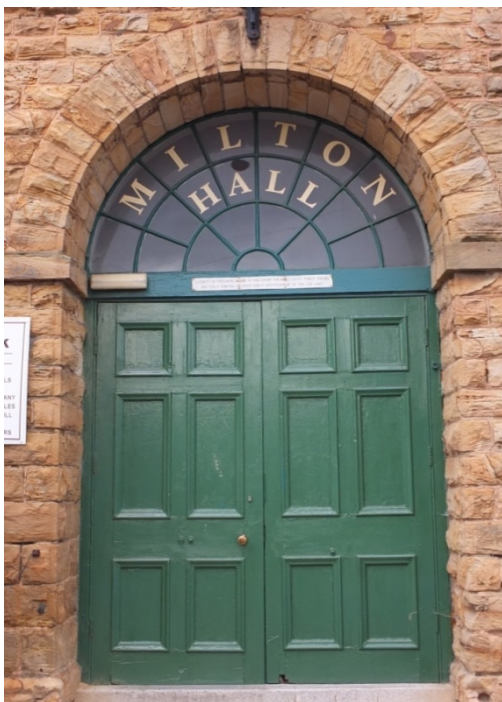
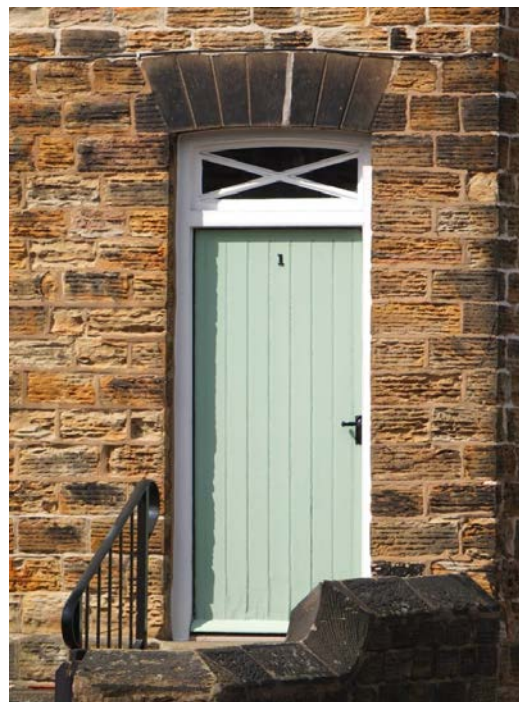
Photos 22 and 23 – 6-panel doors with decorative metal fanlight (Milton Hall) and plain, vertically boarded door with timber fanlight below mock segmental arch (Cobcar Terrace)

10.4.8 One of the repeated features, particularly in the mid and later 19th century properties is mock segmental arches over windows. These are single pieces of stone, carved to look like a more expensive segmental arch (see photos 23 and 24).

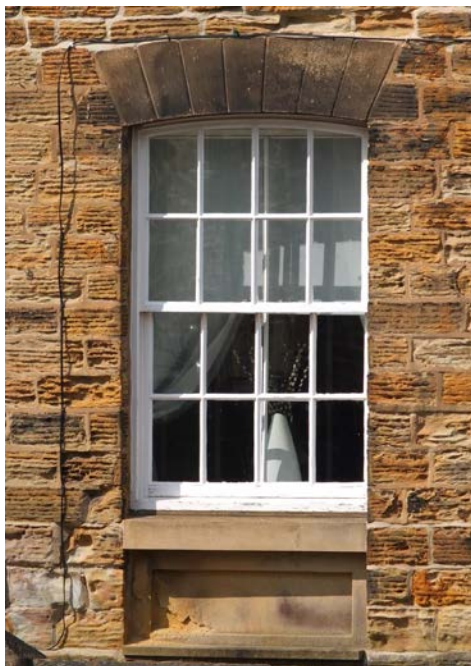
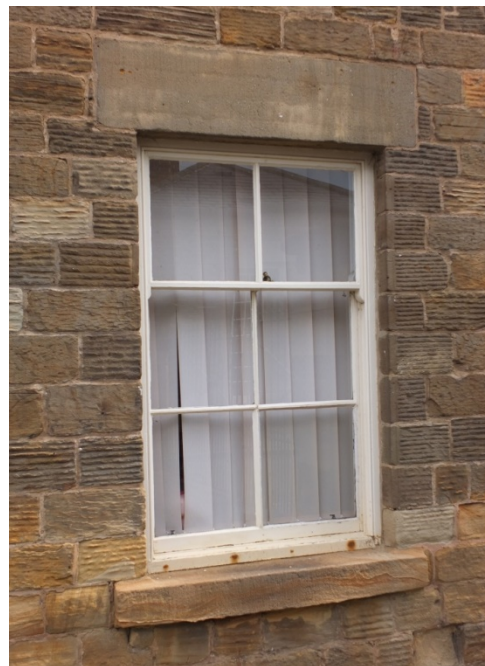
Photos 24 and 25 – timber sliding sash windows of different types, with narrow glazing bars

10.6.1 Although there are a variety of styles of windows and doors in evidence in Elsecar, consistency is the main factor to consider, particularly where this involves a row, terrace or group of historic buildings with a singular or shared style. In Elsecar, doors were traditionally constructed in timber and were either plain vertically boarded, ledged and braced, or panelled – usually six panelled (see photos 22 and 23). Panelled doors often include decorative fanlights and glazing above the door which should always be retained (including the original glass if it survives) and decorated white to match the frame. Windows have traditionally been made of timber or metal and there is evidence of a number of different window styles throughout the village, including sliding sash, Yorkshire (side sliding) sash and side hung casements (see photos 24 to 27).

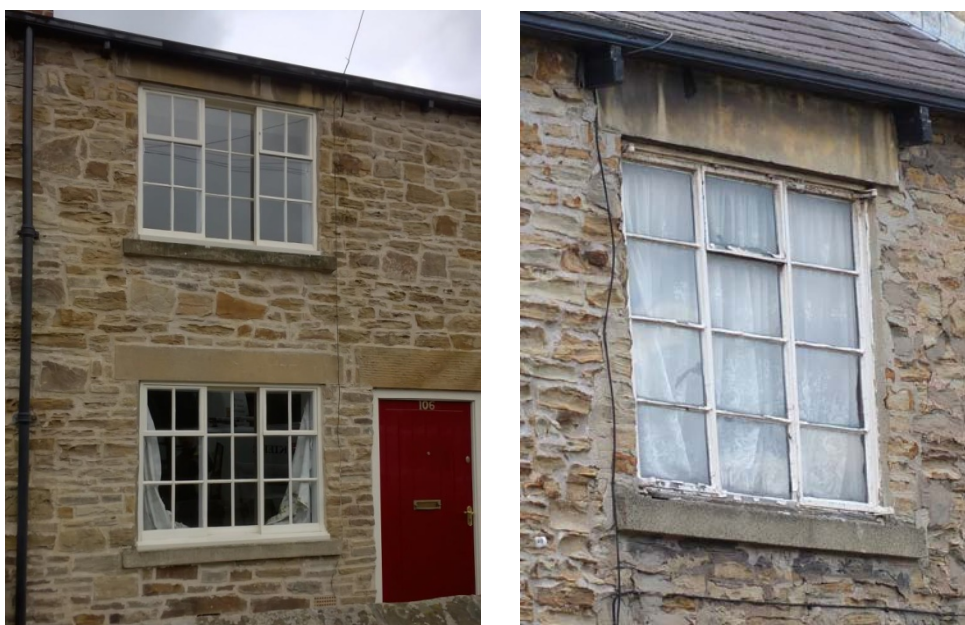
Photos 26 and 27 – Yorkshire sash replacement windows (Reform Row) and metal casement (Station Row)

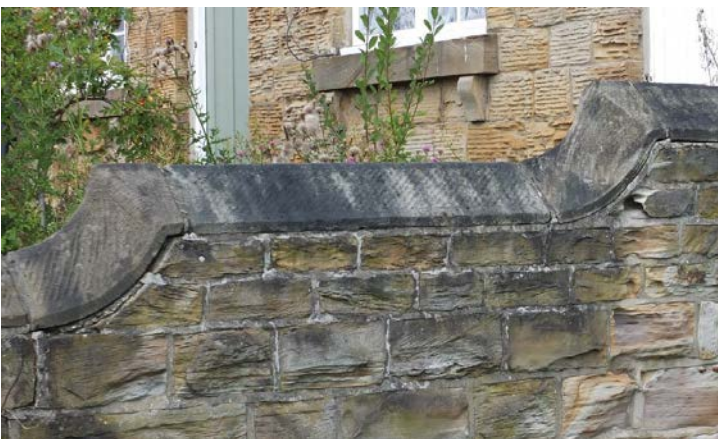
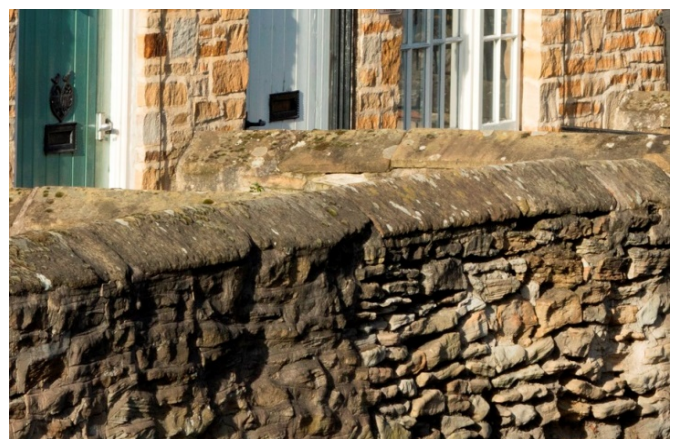
Photos 28 and 29 - Decorative wall coping, Fitzwilliam Street and Reform Row

10.9.2 The majority of the walls have decorative, carved coping stones of different designs (photos 28 - 30). Again, these are an important part of the intended village design and should be retained and repaired if necessary.

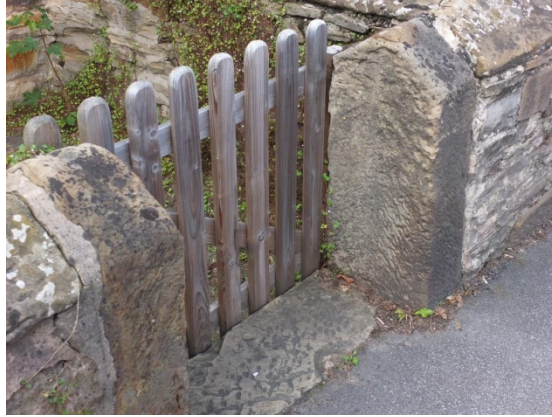
Photo 30 – Gate posts with simple carved tops and gate set behind

10.9.5 Some properties currently have low, metal gates, although these probably replaced earlier wooden gates. If a gate is required, wooden gateposts should be set behind the existing stone posts (see photo 30). Gates should not be fastened straight into the stonework, as this is likely to damage the stone. Gates should be in proportion and should not be significantly taller than the walls to either side.

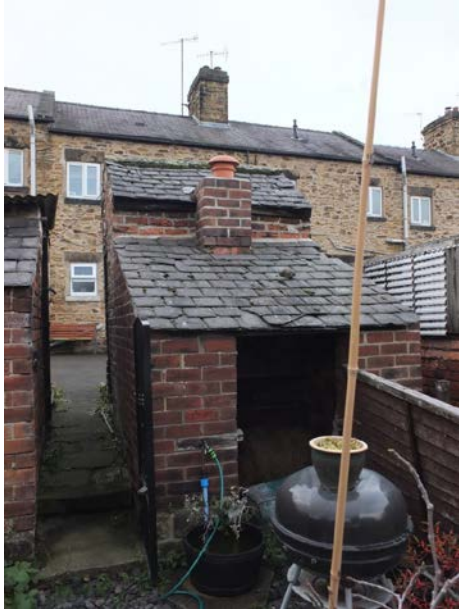
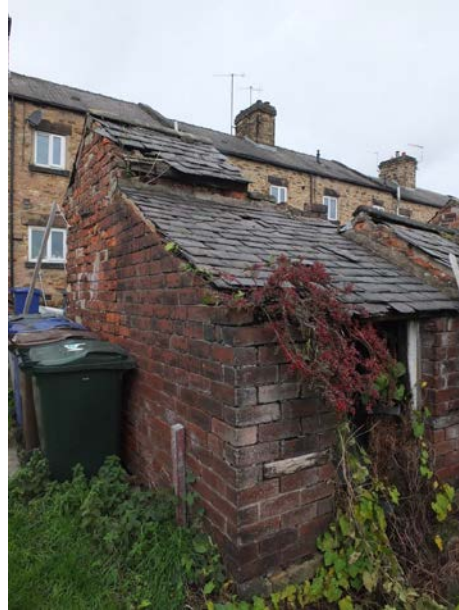
Photos 31 and 32 - Brick outbuildings, Fitzwilliam Street

10.9.6 Many of the historic rows in Elsecar, including Fitzwilliam Street, Old Row and Reform Row, have surviving historic outbuildings behind the main properties. Roofs are generally of Welsh slate and walls are of red brick. These were an important part of the original planned design of the village, and were intended to provide modern facilities for residents and promote a healthy living environment. They include washrooms, piggeries, coal houses and kennels.

10.9.7 Outbuildings should be retained and repaired where necessary. The same principles apply to outbuildings as to main properties. Pointing should always be in lime mortar and materials should be carefully chosen to match existing. Architectural features should be retained and repaired where necessary. Outbuildings may be suitable for sensitive conversion to summer houses and home offices, however care should be taken not to change the massing or roof height of the buildings, particularly where the building is part of a group and/or there are other neighbouring buildings of the same design. Planning Permission may be needed for conversions and other external works. Please contact the Conservation Officer for more details.

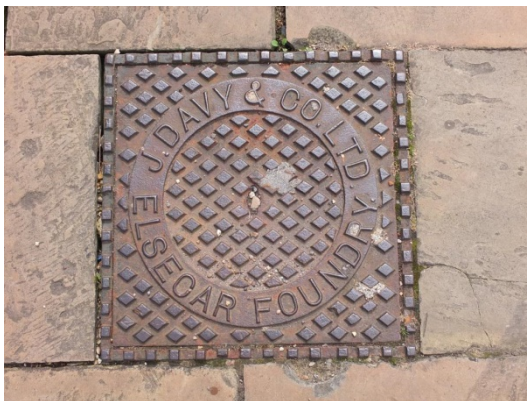
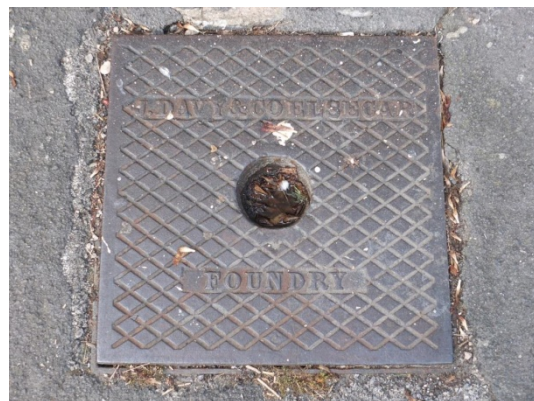
Photos 33 and 34 - Locally made drain covers from the Davy Foundry, Elsecar

10.9.8 Historic drain covers usually carry the name and location of the foundry that made them, and sometimes a date. The Davy Foundry in Elsecar made drain covers and rain water goods from the 1870s until the 1980s. Many of their covers still survive in the village, including in back yards and gardens. Other covers and grates were also made locally, including at the Milton Foundry. These are an important part of the village's industrial and social heritage and should be retained and reused.

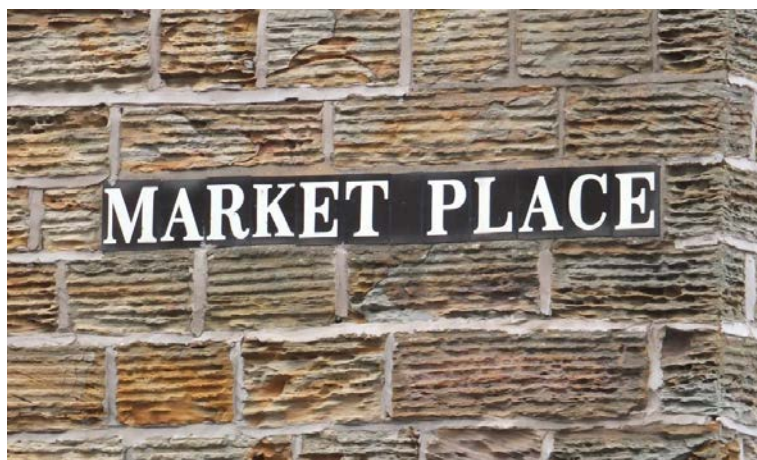
Photo 35 - Inlaid ceramic tile street sign, Market Place, Elsecar

10.10.1 There are a number of historic street signs in Elsecar that are made of inlaid ceramic tiles (photo 35). These are an important feature within the conservation area and should be retained and repaired.
